Manhole Inspection Summary

Manhole # S41A2_023MH

Location Address: **3901 8th St.**

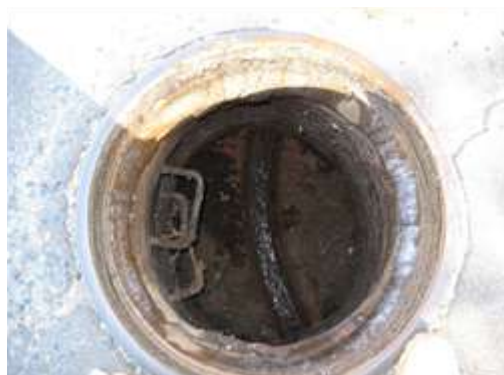
Top View

Condition: ☐ Sound ☒ **Cracked** ☐ Root Intrusion ☒ **Loose Brick** ☐ Deteriorated

Infiltration: ☐ None ☒ **Joint** ☒ **Cracks** ☐ Mortar ☐ Roots ☐ Wall
